Conservation of a historic building through sympathetic thermal enhancement.

Conservation of a historic building through sympathetic thermal enhancement

J. Stinson, J. Bros Williamson, A. Reid & J. Currie
*Scottish Energy Centre, Institute for Sustainable Construction,
Edinburgh Napier University, UK*

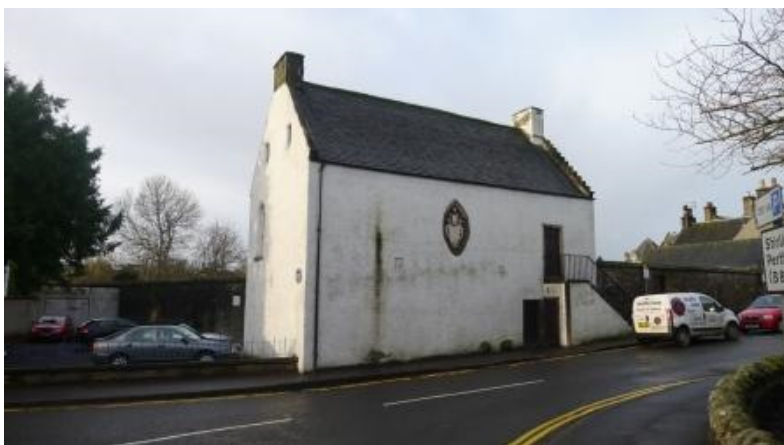
The library has a simple rectangular footprint with masonry lime bonded walls and crowstepped gables in the traditional Scottish vernacular, with chimney stacks on both gables (Figure 1). The elevations and gables have been harled with a wet dash cement finished with modern masonry paint. Such finishes are not considered ideal in building conservation terms in that they tend to lock in moisture. Bituminous roofing felt was installed under the slates during a period of refurbishment in the mid-1980s further preventing ventilation through the roof

Figure 1: Leighton Library, Dunblane (2012).

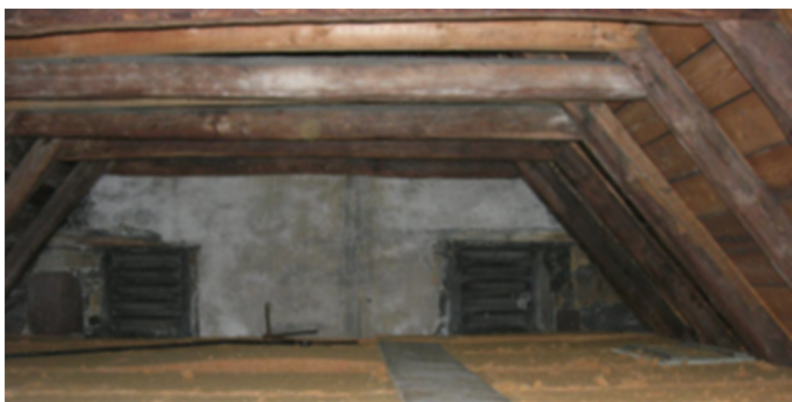
fabric. Roofs with bituminous roofing felt in place typically require other methods of ventilation, such as roof vents, or venting at the ridge and eaves. In the case of the library the previous means of ventilating this roof space was through two large louvered vents on the south-east gable. These had been partially closed off, but were re-opened, ensuring an adequate degree of ventilation into the roof space (as shown in Figure 2).

Figure 2: The louvered opening provides cross ventilation (courtesy of Historic Scotland).

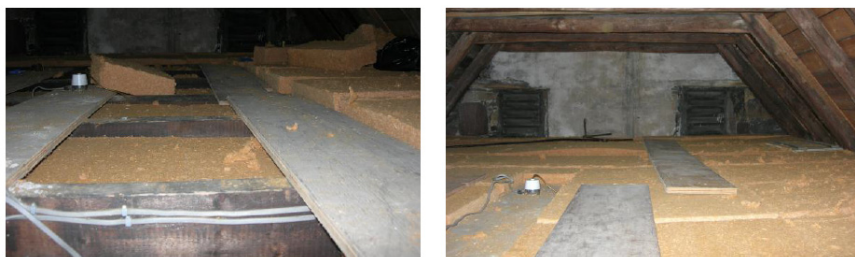
The insulation of the ceiling involved the installation of two layers of 100 mm wood fibreboard insulation directly above the internal timber panel finish. Made

from a renewable resource (wood), this material was considered appropriate for traditionally constructed buildings, where the use of materials with a low resistance to liquid vapour and hygroscopic and high capillarity active qualities are considered important. The upper level of insulation finished 50mm above the timber ceiling joists (see Figure 3). The wood fibreboard insulation used has a manufacturer stated thermal conductivity value of 0.038 W/mK and a water vapour/diffusion resistance factor 3 μ (mu-value) (BS EN ISO 10456: 2007 [5]).

Figure 3: Photographs of wood fibreboard insulation. Crawl boards were used to assist installation (courtesy of Historic Scotland).
